**DUBLIN CORPORATION**  
**DRAINAGE DEVELOPMENT DIVISION**

**RIVER DODDER — 1986 FLOODING  
REPORT**

December 1986

Chief Engineer  
Engineering Services

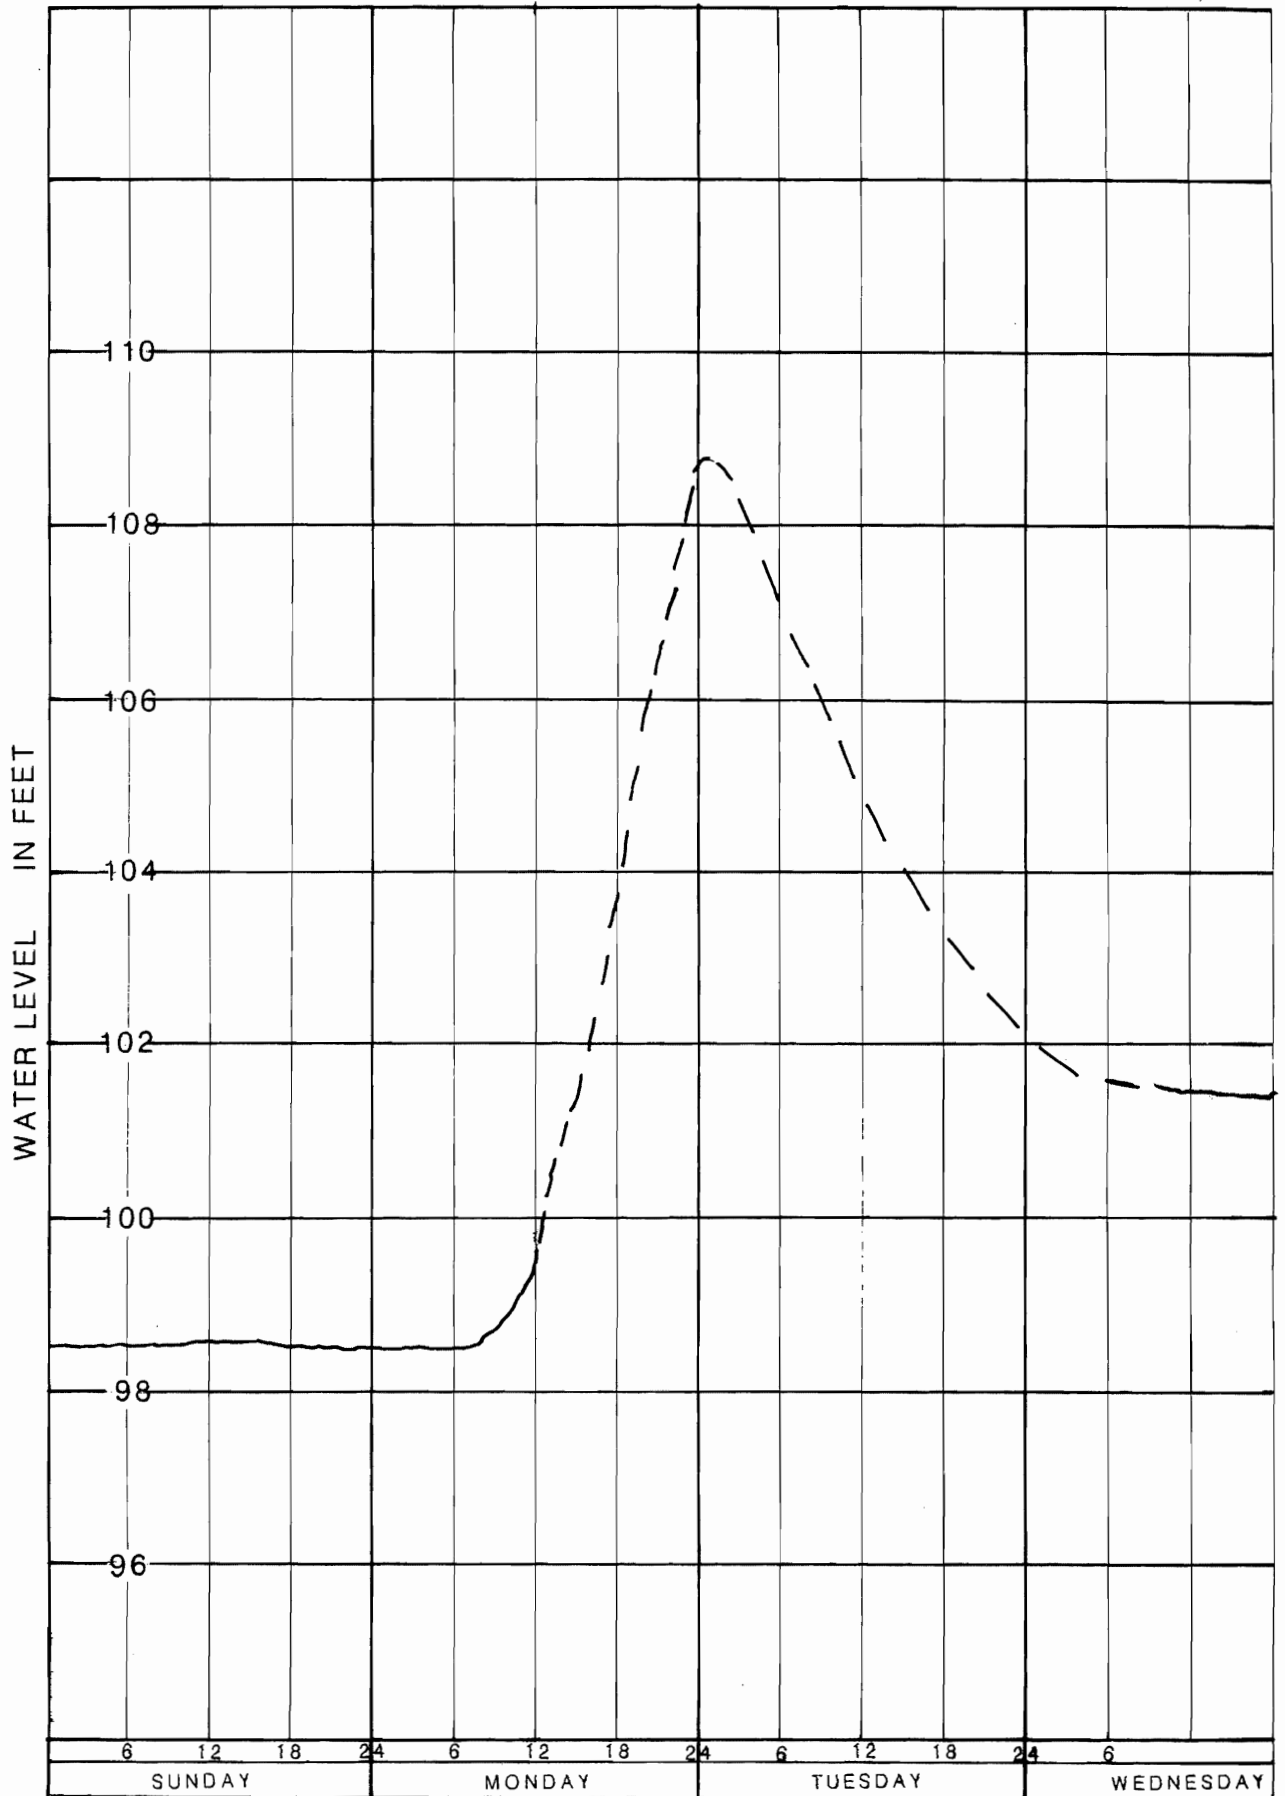
Flows in the River Dodder are measured at Bohernabreena and at Orwell while new flow measurement stations have been operating on the Rivers Owendoher and Slang for the last few years. On the day of the storm the Orwell Gauge operated successfully only until noon of the 25th. However, the level of water was observed at various times during the evening and it was possible to measure accurately the peak flow from a clear high water mark inside the gauge house (33.03 mod). In addition, water levels were noted on the following day by personnel from An Foras Forbartha who also measured the flow in the river at that time. Accordingly, it has been possible to construct with reasonable accuracy the Orwell hydrograph and this is shown in Fig. 1 overleaf.

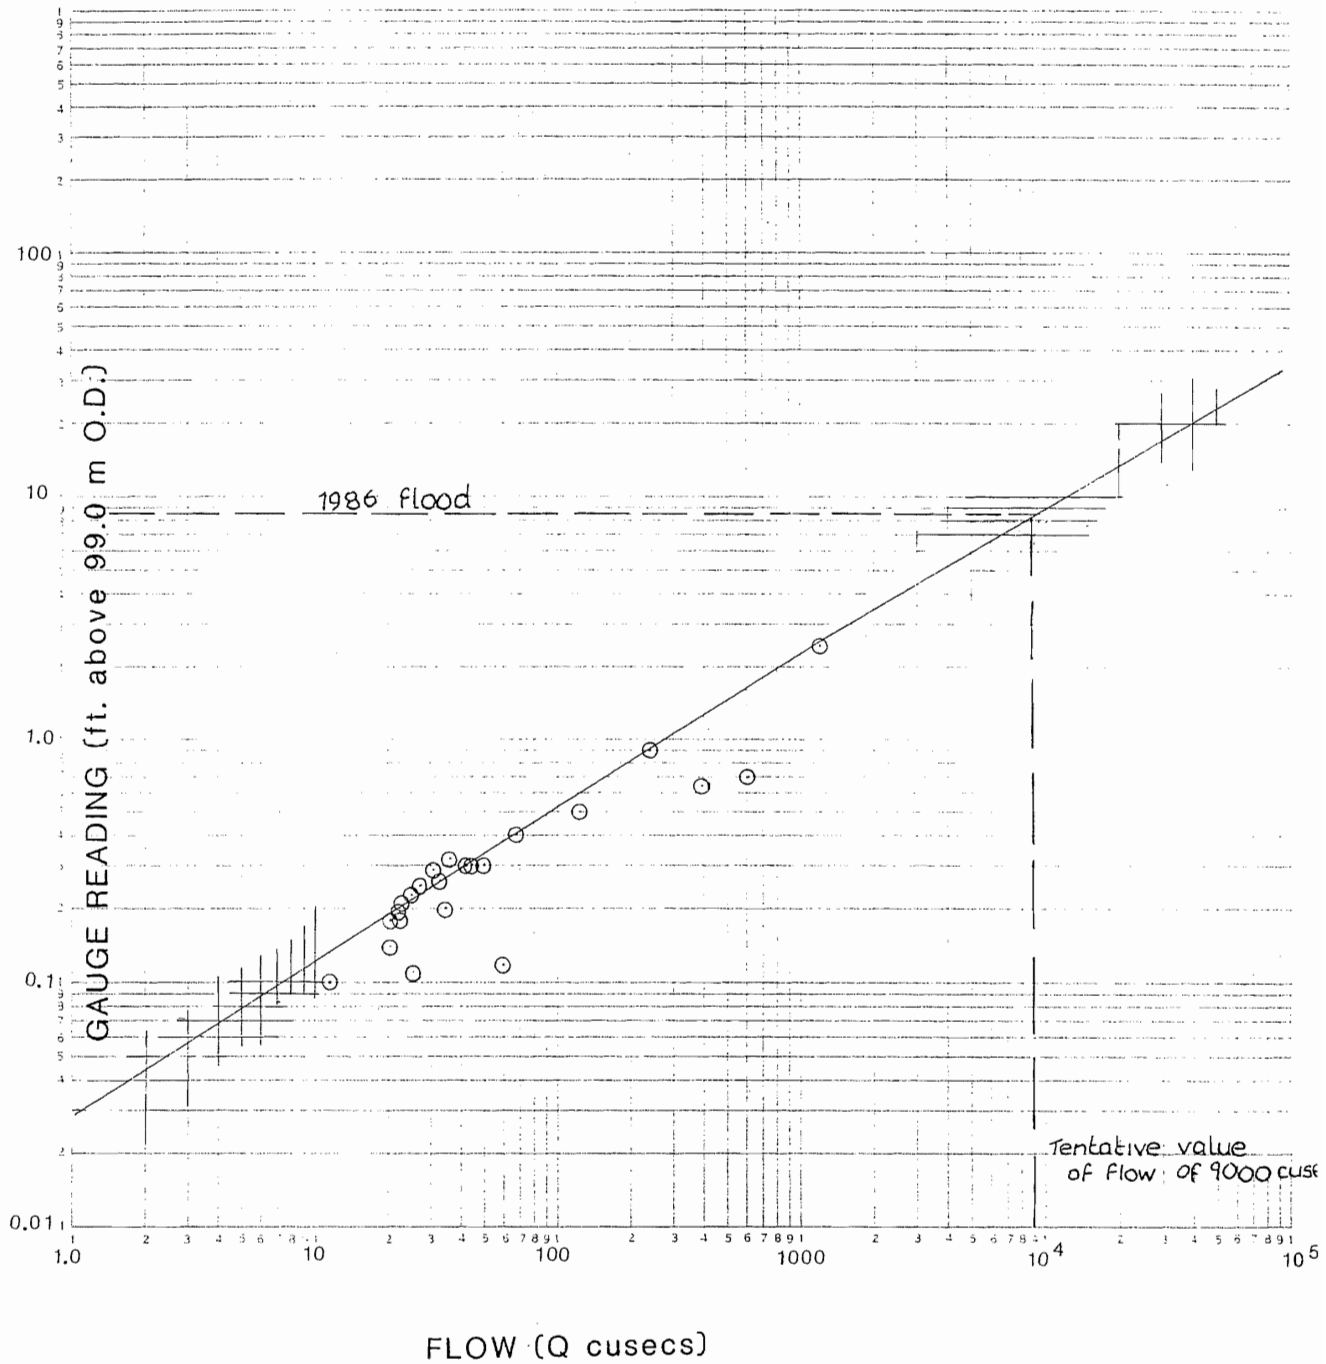
Fig. 5

We have combined the 2 sets of data, which we found to be consistent and produced a new rating curve for Orwell Bridge Gauging Station. This is given in Fig. 5.
