# Flood Map Update

## MR018 Malahide

**Version 1.0**  
**March 2026**

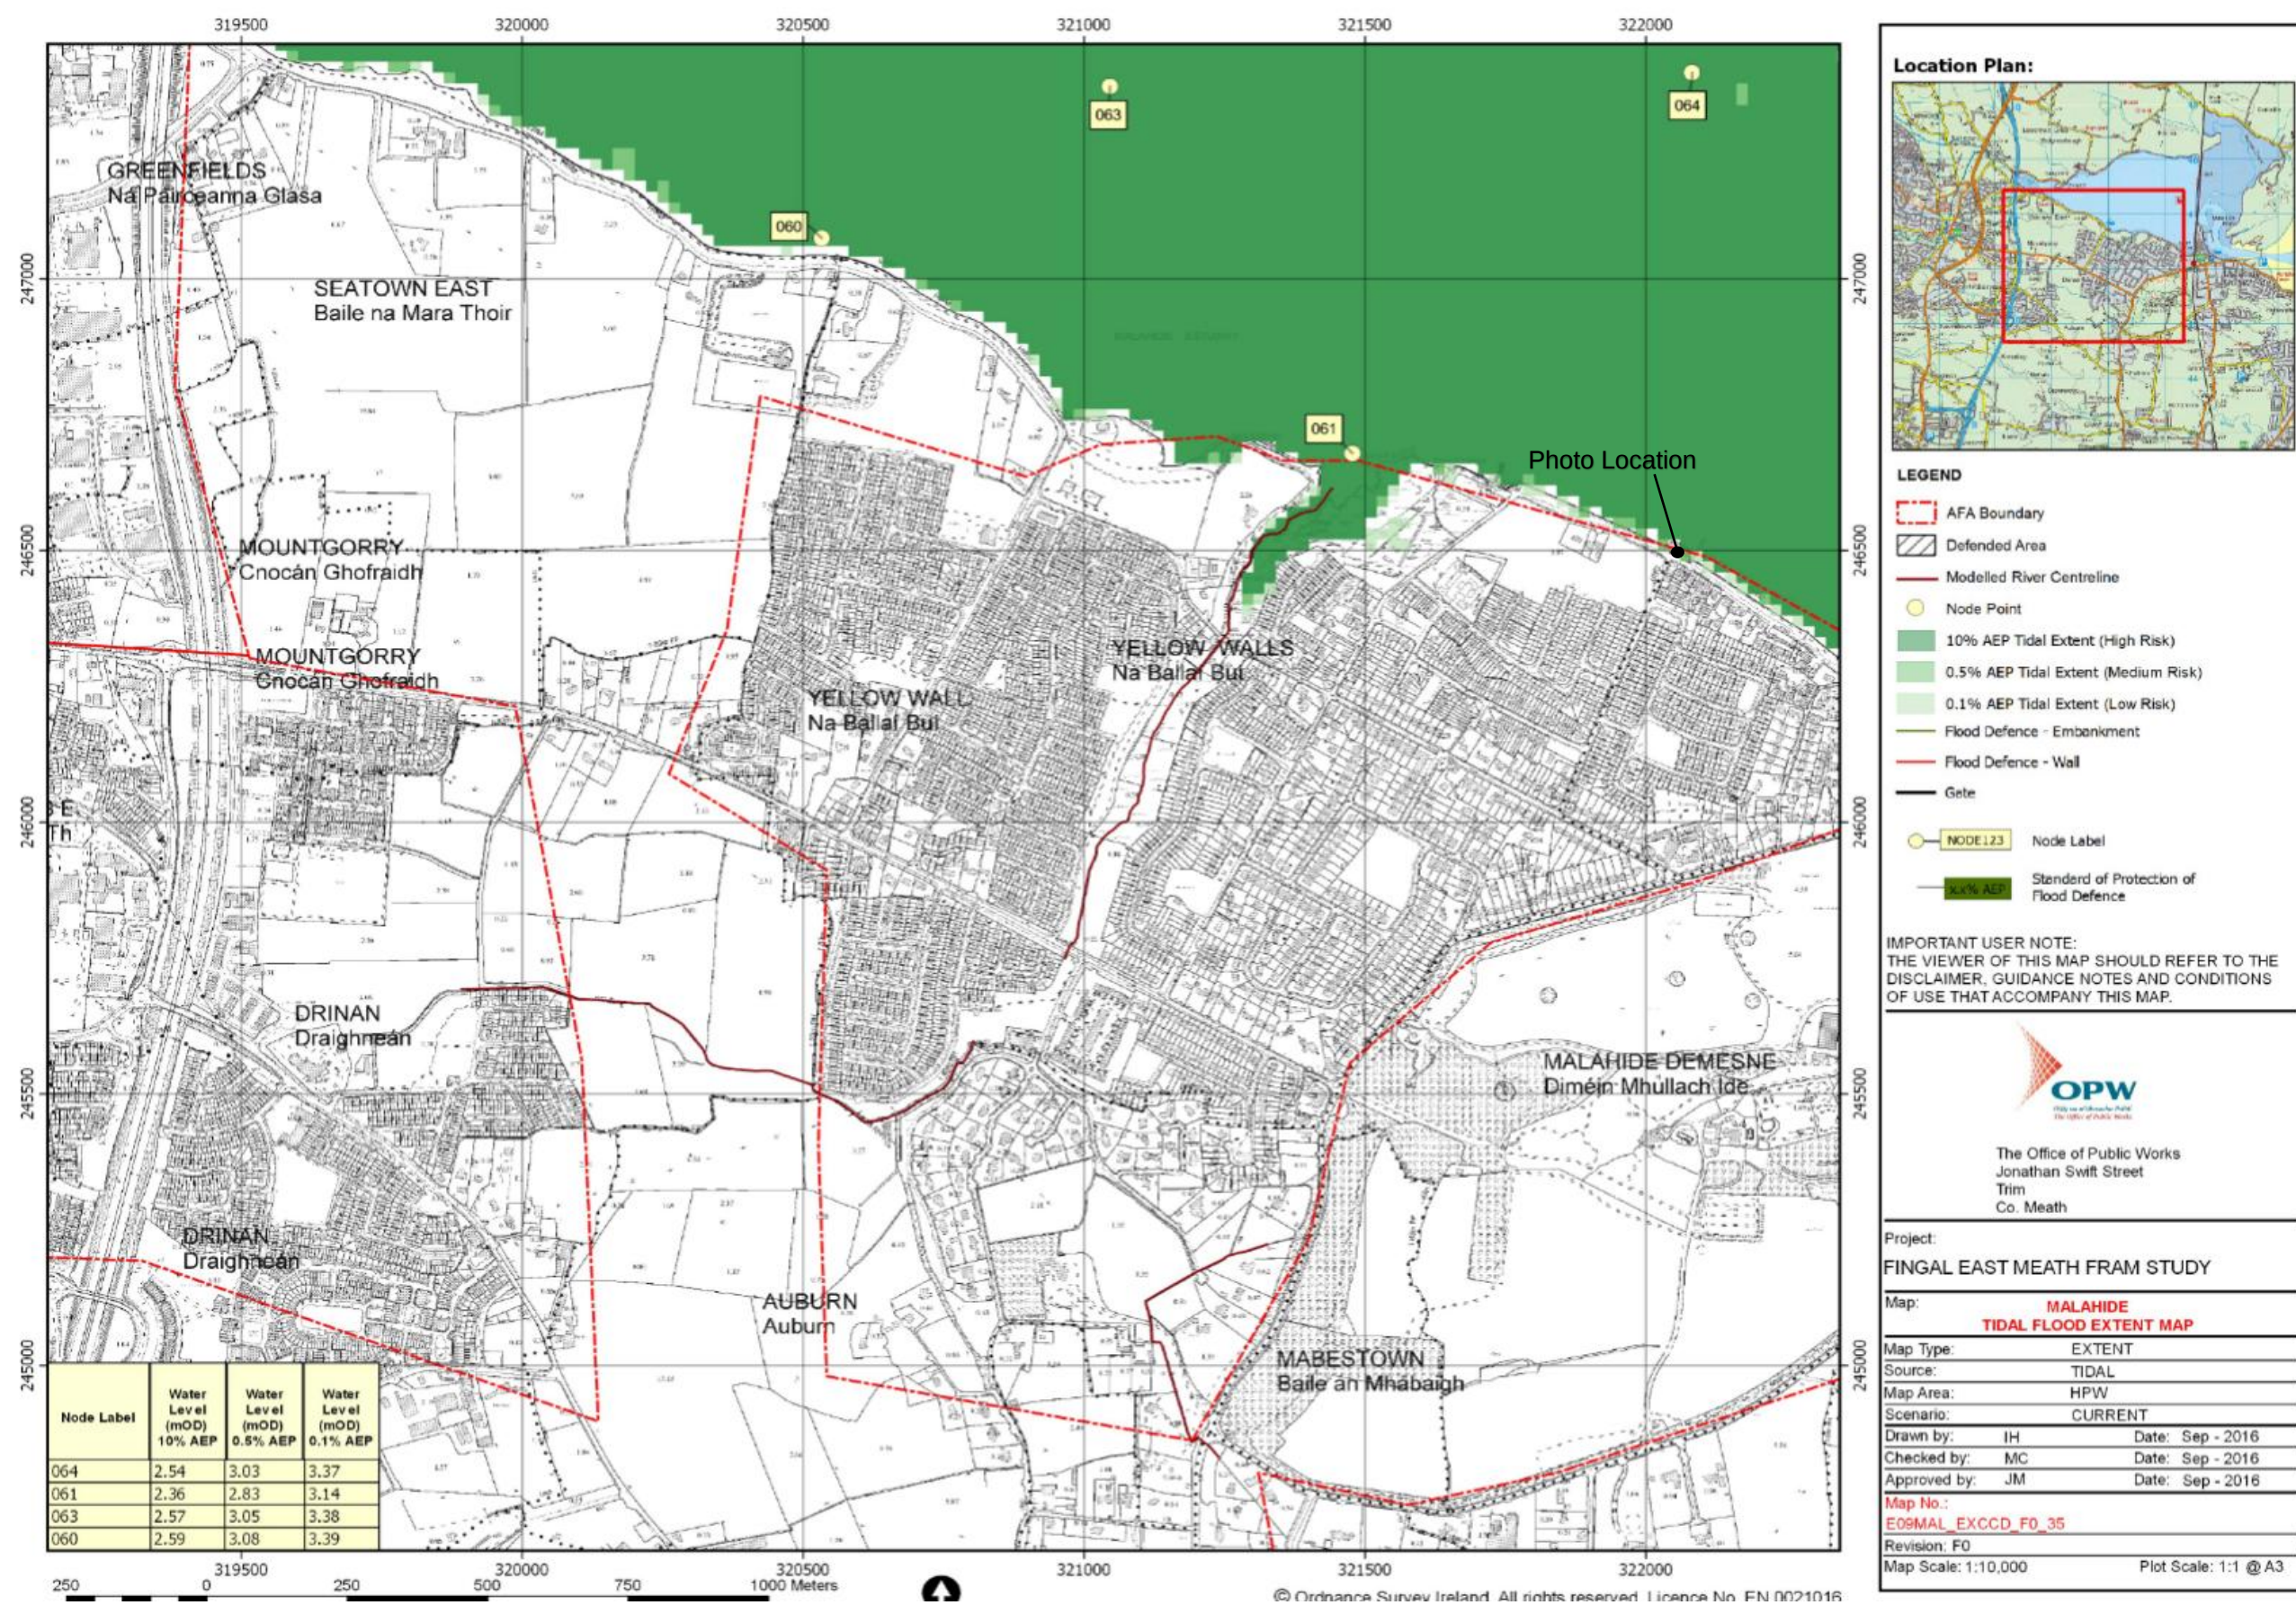
Figure 2-1; Tidal Flood Extent Map

The OPW received correspondence from Fingal County Council that identified an issue with flood extents displayed on [Floodinfo.ie](http://Floodinfo.ie). Fingal County Council provided evidence of flooding along Bisset Strand, Malahide, see Figure 2-1 for the photo location and Figure 2-2; Flooding on Bisset Strand, Malahide for the photo itself. This flooding is not shown in the CFRAM maps, which only show marginal flooding in all events for that area. As evidence was presented by a recent flood event which called into question the OPW published Flood Map, a Map Update is warranted. The OPW's Past Flood Database also indicates that the Bisset Strand and the Estuary Road areas are subject to recurring coastal flooding.

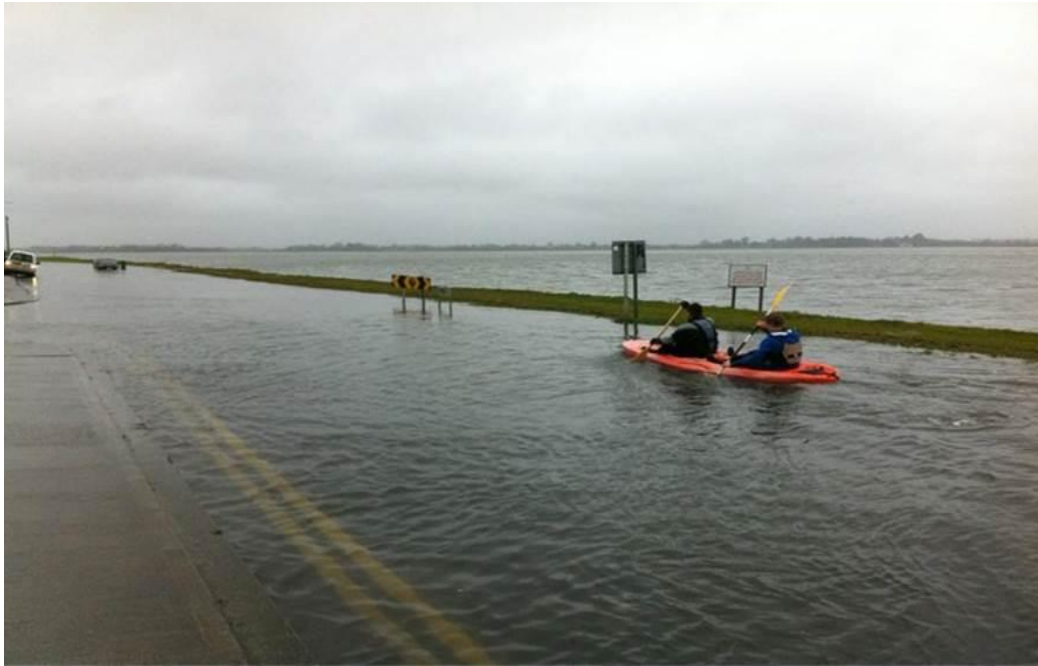
*Figure 2-2; Flooding on Bisset Strand, Malahide*

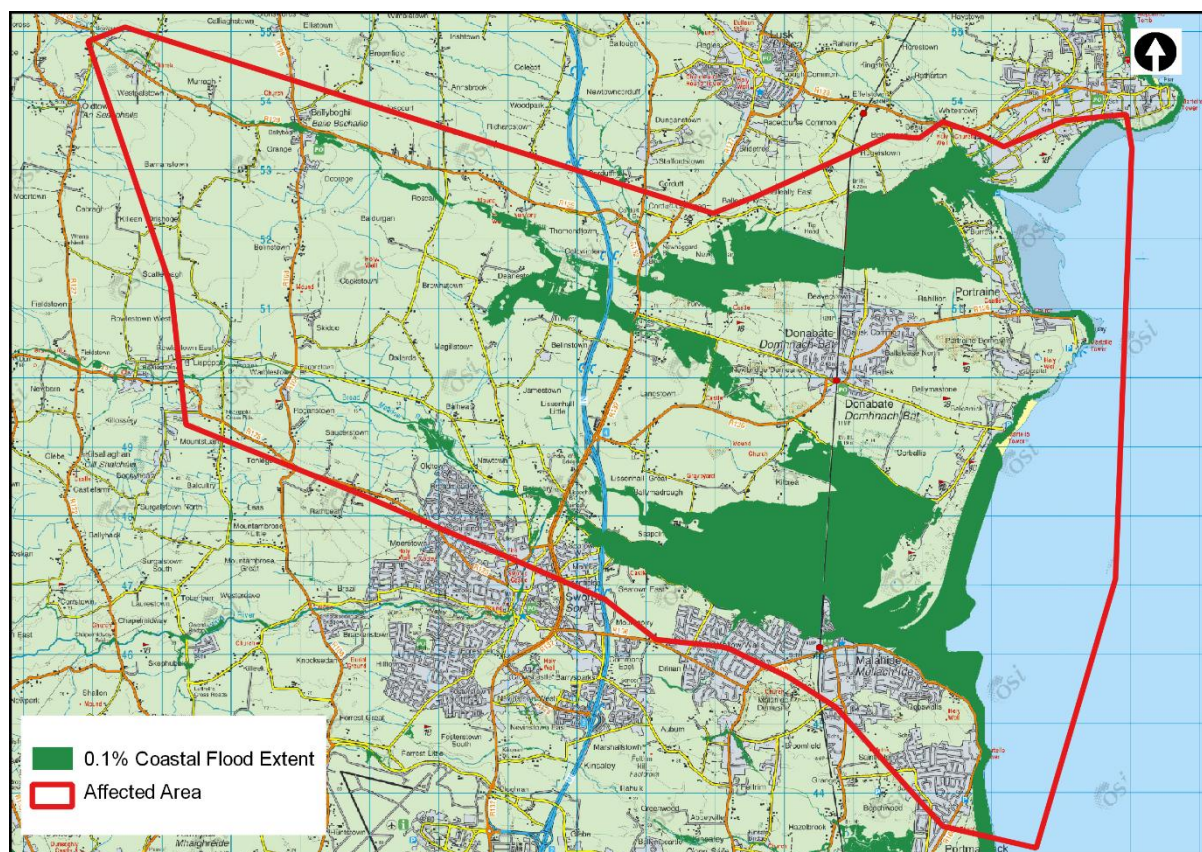
Figure 3-1; Overview of Affected Area

The coastal flood mapping in this area was produced by the Fingal East Meath Flood Risk Assessment & Management Study (FEMFRAMs). A review of the original data produced by the FEMFRAMs identified an error in the displayed coastal flood extents. The source data was then re-extracted from the FEMFRAMs hydraulic model results to provide appropriate flood maps. A further review identified that the issue was not constrained to Bisset Strand. The full extent is shown in Figure 3-1.

The data updated included the Current Scenario coastal flood extents, depths and node data for the area shown in Figure 3-1.

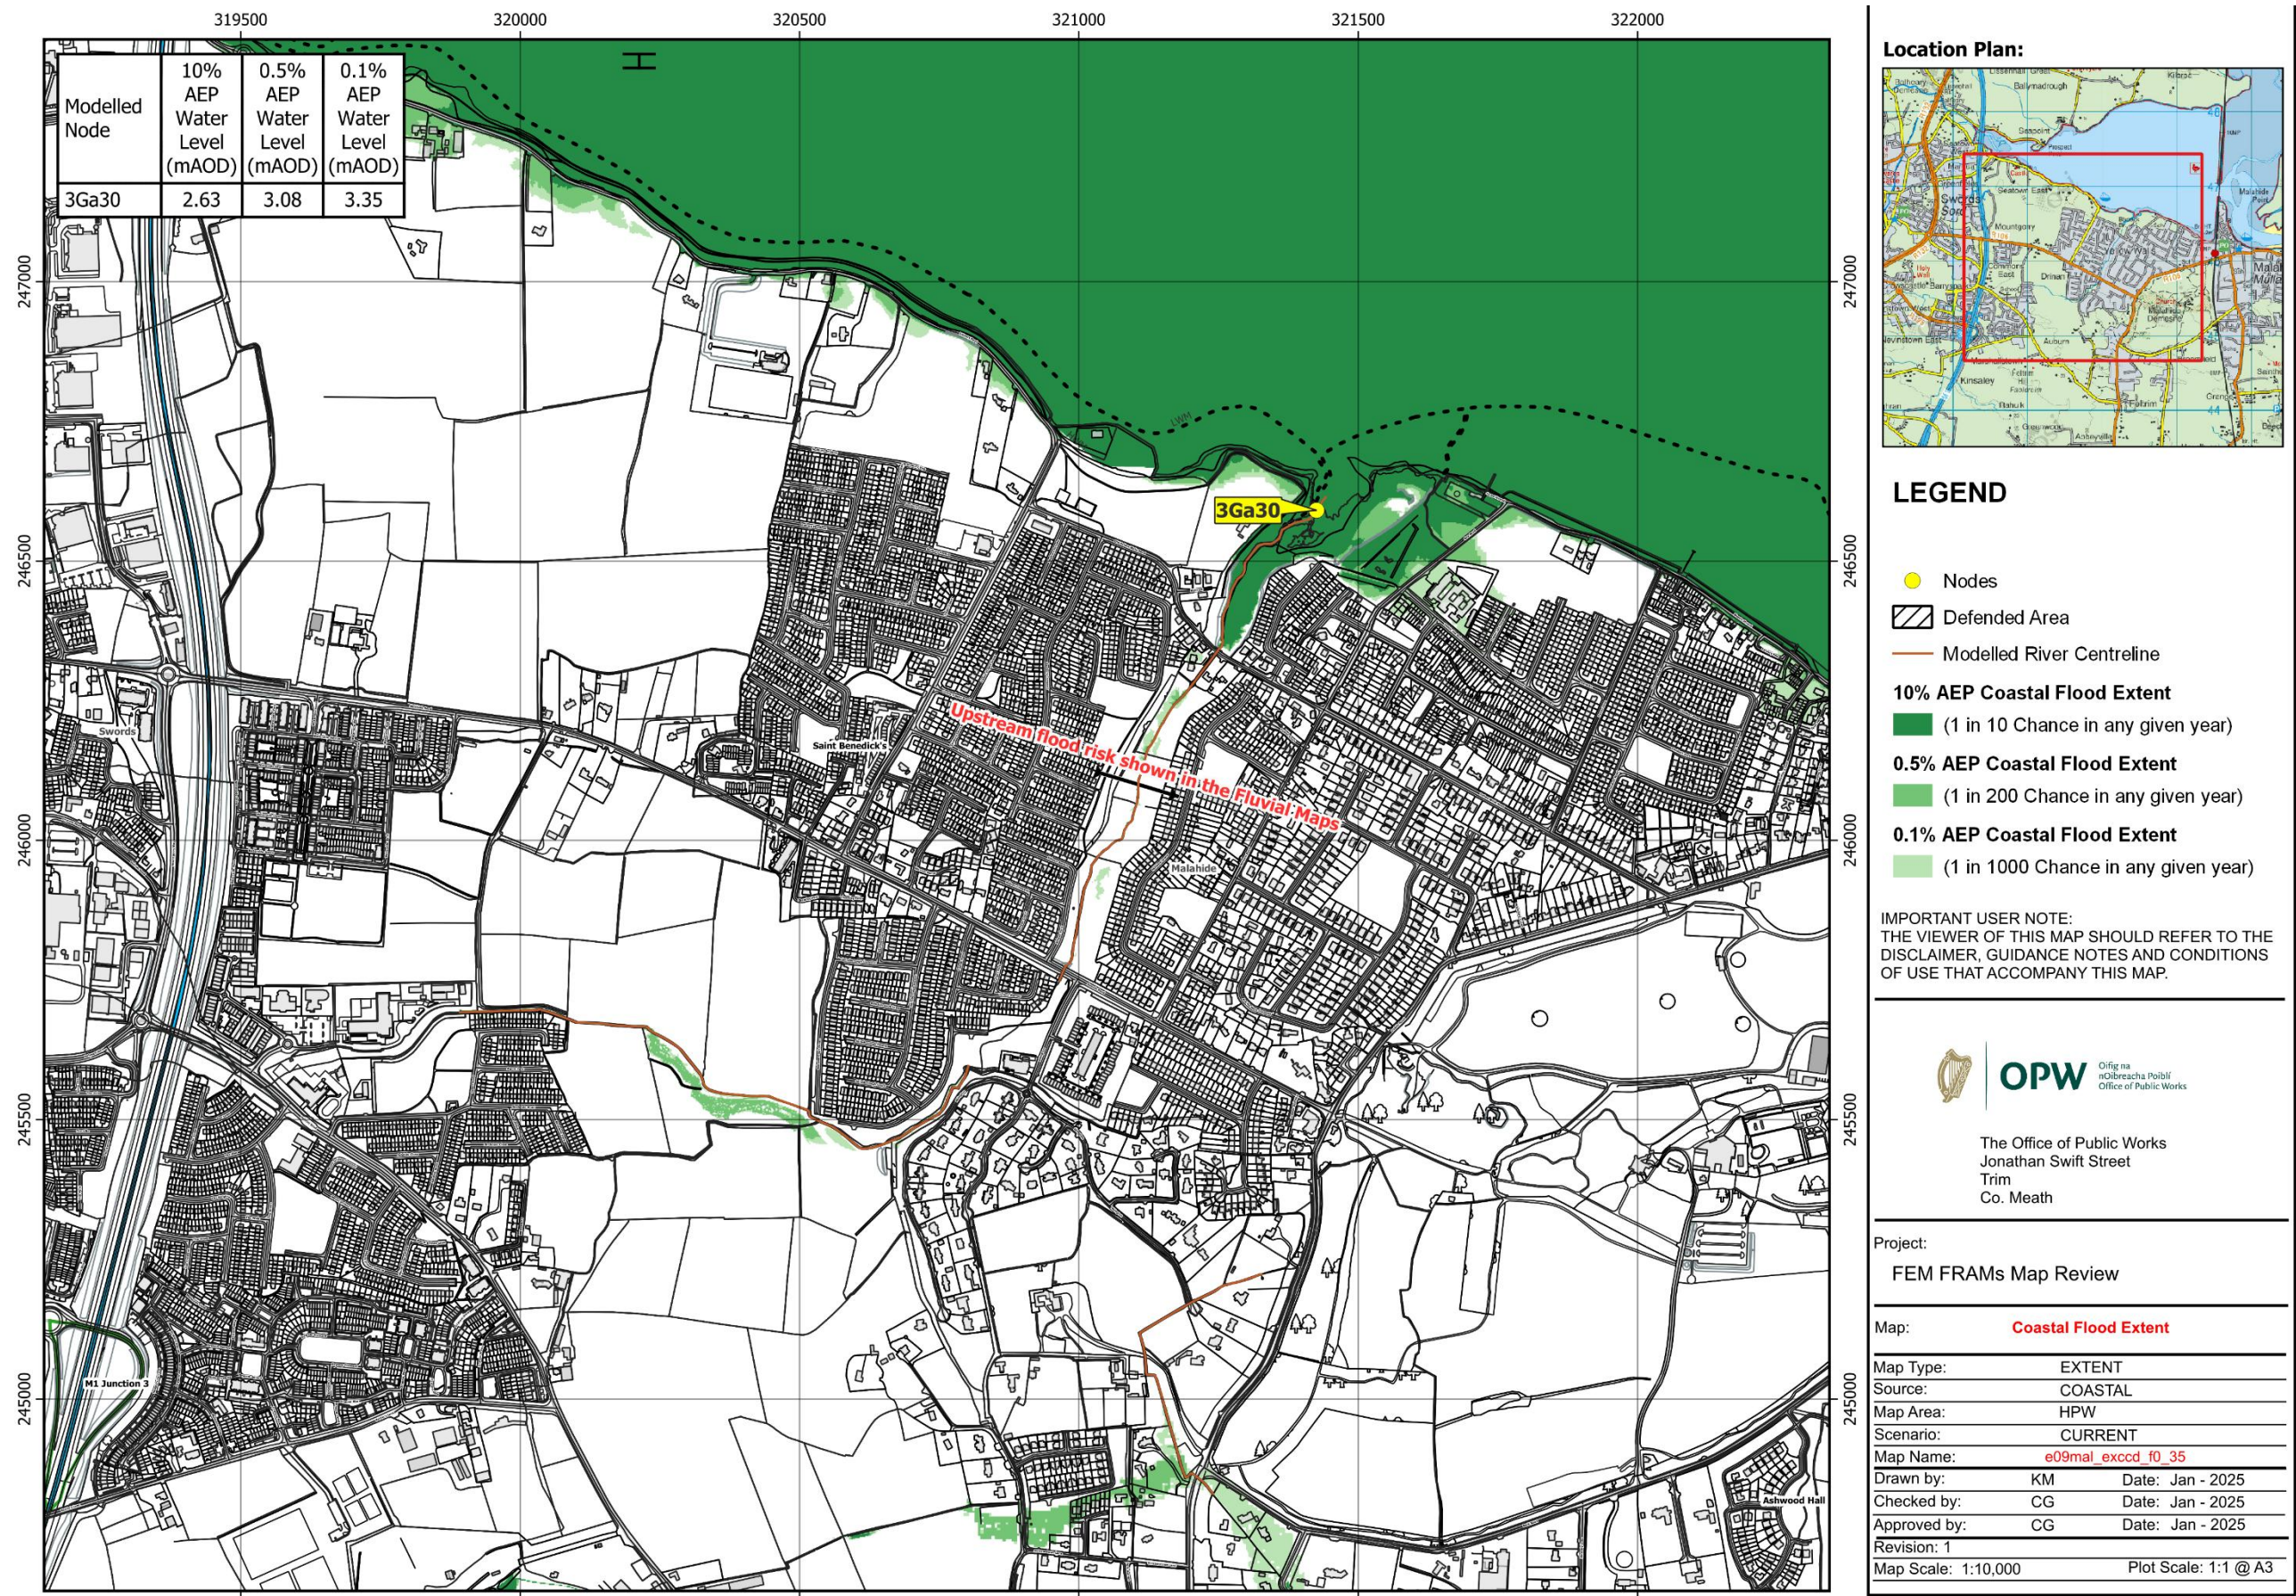
Evidence was presented for a flood event which called into question the published OPW Flood Map. Upon review it was determined that incorrect coastal flood extents and depths were originally extracted from the flood model, and the maps have been updated to reflect the correct model results. Bisset Strand is now shown within the flood extents, as supported by the available evidence, see Figure 3-1; Updated Flood Map

The following PDF tiles have been revised as part of this Map Update:

- staffordstown\_turvey17
- staffordstown\_turvey18
- donabate19
- portrane20
- swords24
- donabate22
- portrane20
- malahide35
- malahide36
- malahide40
- malahide44
