# RIVER TOLKA FLOODING STUDY

## TECHNICAL REPORT VOLUME 2: RIVER MODELLING REPORT

*October 2003*

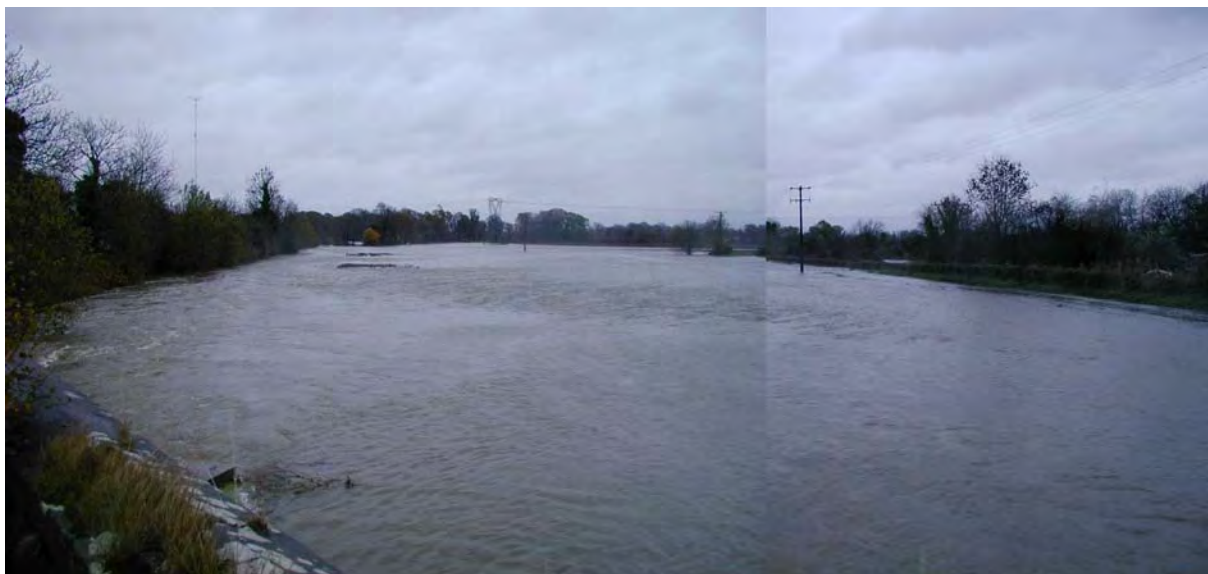
Figure 1.1 - Extent of Flooding on 6/11/00 looking downstream from Loughsallagh Bridge

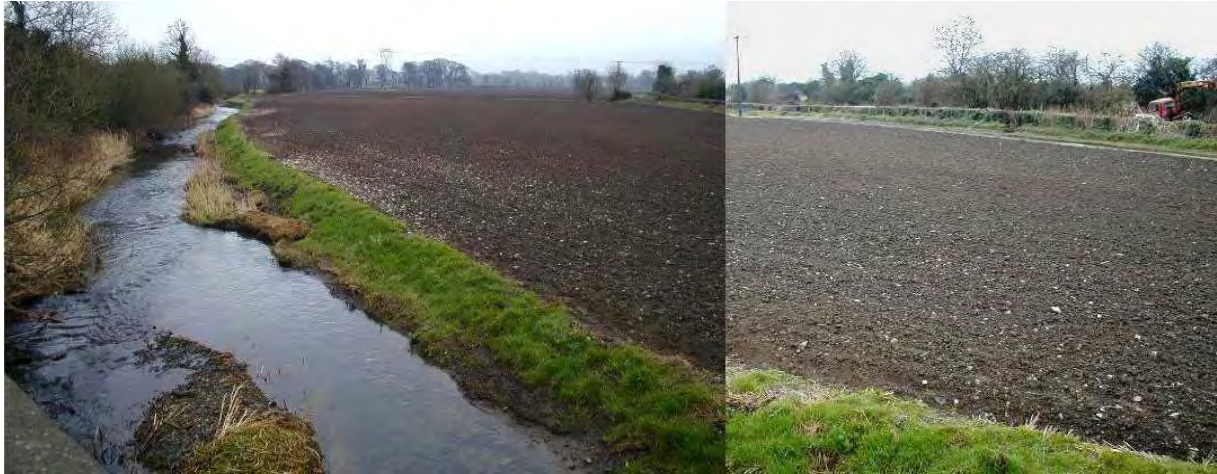
**Figure 1.2 - Comparative photograph, looking downstream from Loughsallagh Bridge**

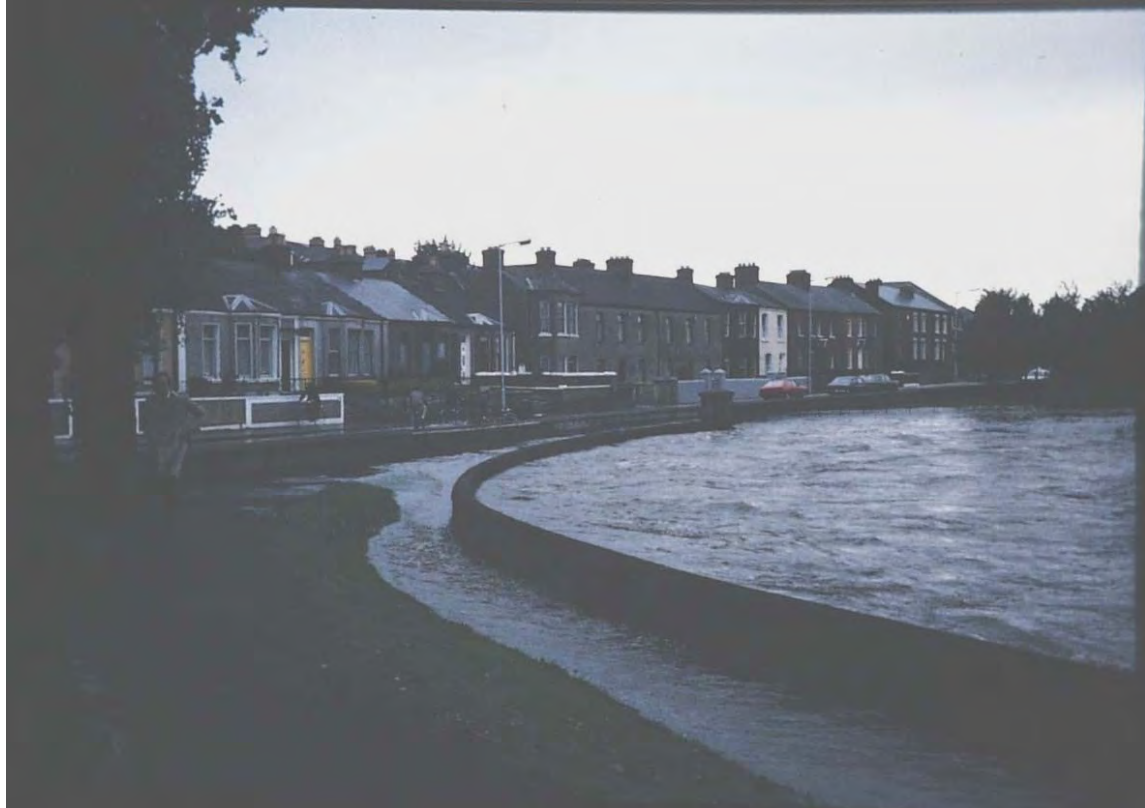
**Figure 3.1- 1986 Flood - Botanic Avenue**

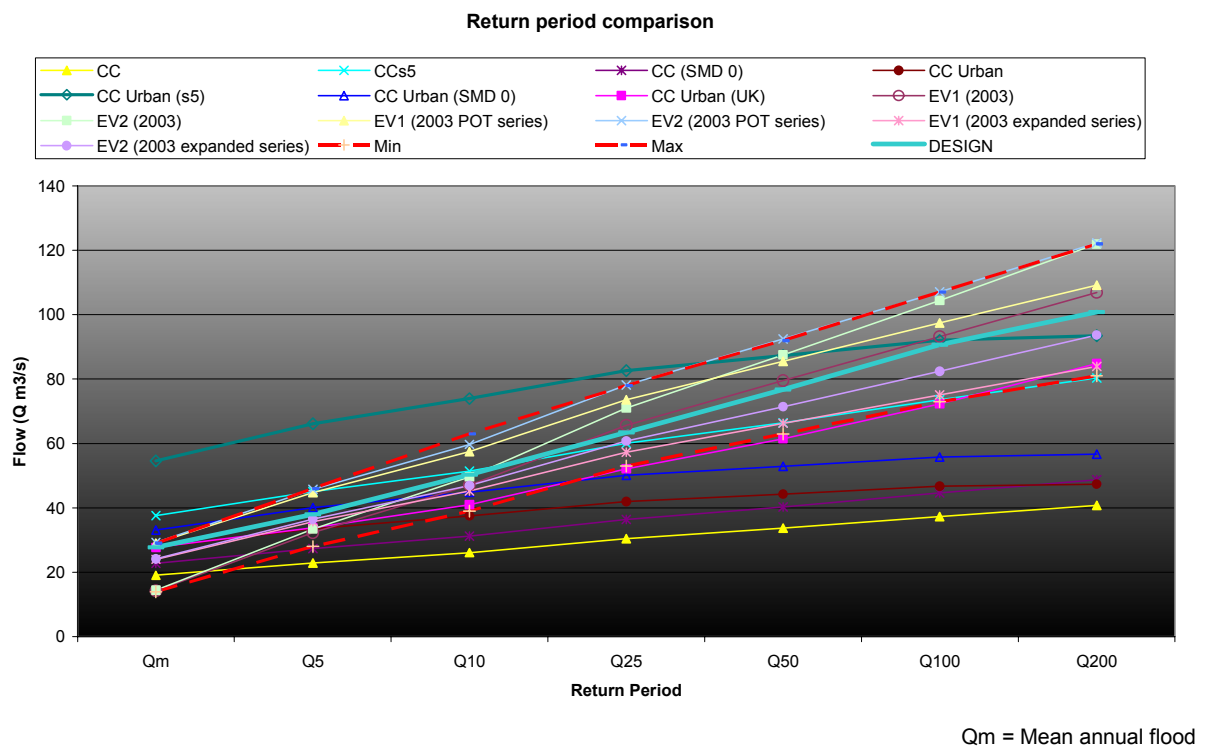
**Chart 5.2 Comparison of growth curves**

The results of the analyses described above are tabulated and included in Table 5.2. This provides a summary of the analysis of historical catchment flows. While no one method can be considered definitive, the EV1 (Gumbel) and EV2 distributions are considered a good statistical method for arriving at flood estimates based on a sample of real world data. Three such analyses have been investigated to assess the skew resulting from sampling choice and distribution errors. Additionally, Catchment Characteristics method is widely used in Ireland for flooding studies and a number of parameters were checked to establish their sensitivity in the River Tolka. The results indicate that while the Catchment Characteristics method provides good agreement with predicted mean annual floods, the average Irish regional multipliers appear too low for higher return period events for the Tolka specifically. The Design curve chosen takes into account a number of factors including the errors associated with such an analysis and the limited reliability of the data. Of particular note is that a flow of 85m<sup>3</sup>/s being the largest flow within over 120 years record prior to the November 2002 flood would traditionally have been considered to have a return period in excess of 100 years. This flow is now considered to have a return period of approximately 90 years. The November 2002 flow of 97m<sup>3</sup>/s is now considered to have a return period in excess of 100 years and this is supported by analysis of rainfall runoff relationships in the model.

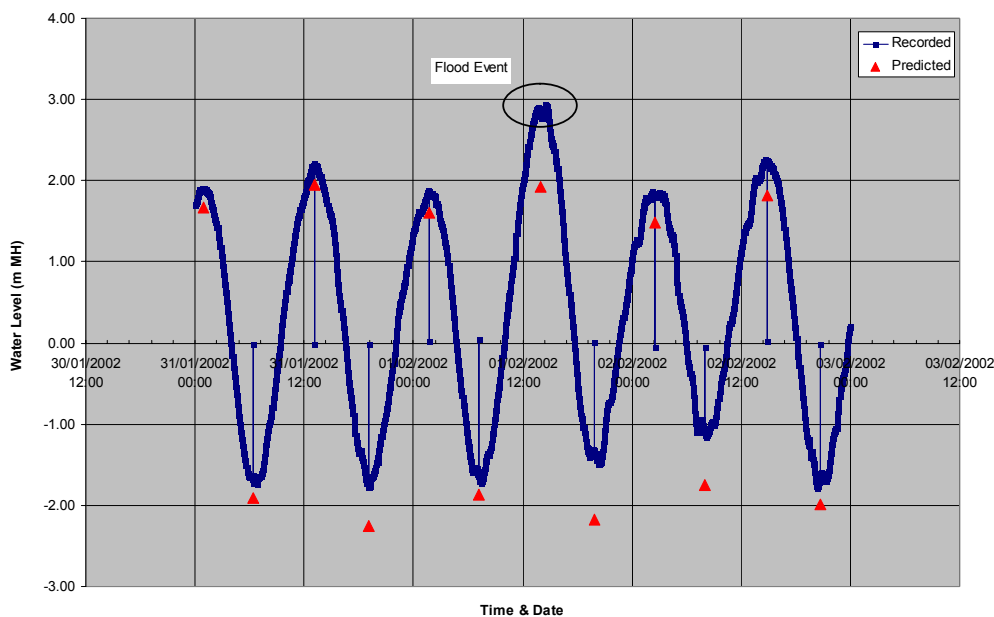
Figure 5.1 below sets out the predicted tide levels from Tide Tables and actual water levels between 31 January and 2 February 2002. The graph reveals that recorded water levels were consistently above those predicted, due to storm surge and wave effects. This illustrates the influence of weather factors on actual tide levels, i.e. extra tide level rise due to low barometric pressure, onshore winds and wave heights.

**Figure 5.1 February 2002 Tide Levels**

Figure 5.1 indicates that due to the wide channel in the lower tidal reaches the increase in level associated with flow is marginal and the tidal level is the major governing factor relating to flood stage (level) in this area.

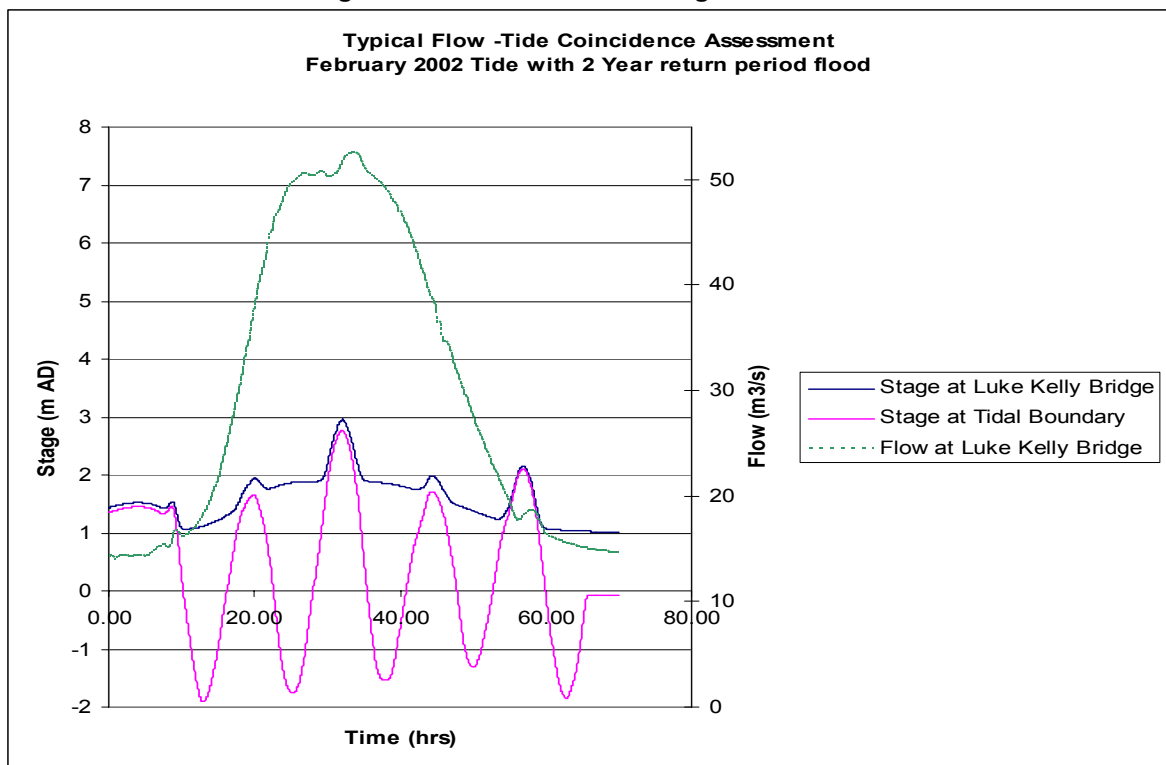
**Figure 5.2 Tides / Flooding Coincidence**

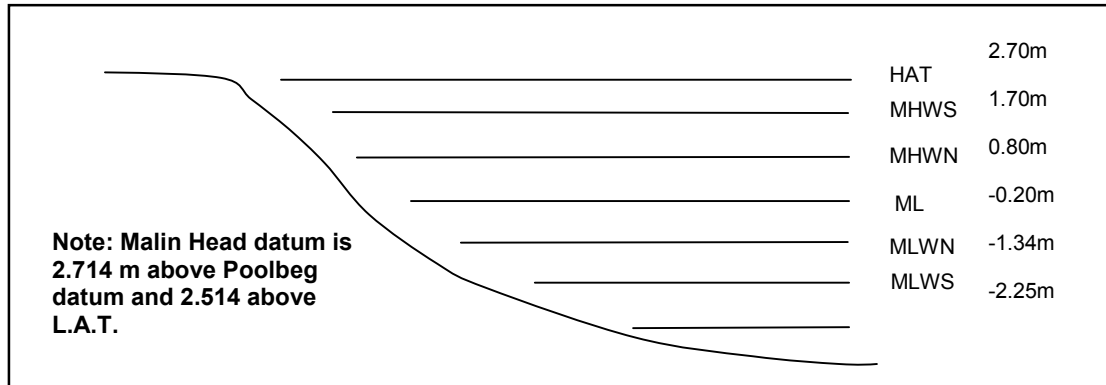
Sea levels are recorded by the Dublin Port Authority and have been provided in metres to Malin Head Datum. The usual tidal range is provided by Figure 5.3 below:

**Figure 5.3 Tide Levels for Dublin Bay (Malin Head)<sup>7</sup>**
