**DUBLIN CORPORATION**  
**DRAINAGE DEVELOPMENT DIVISION**

**RIVER DODDER — 1986 FLOODING  
REPORT**

December 1986

Chief Engineer  
Engineering Services

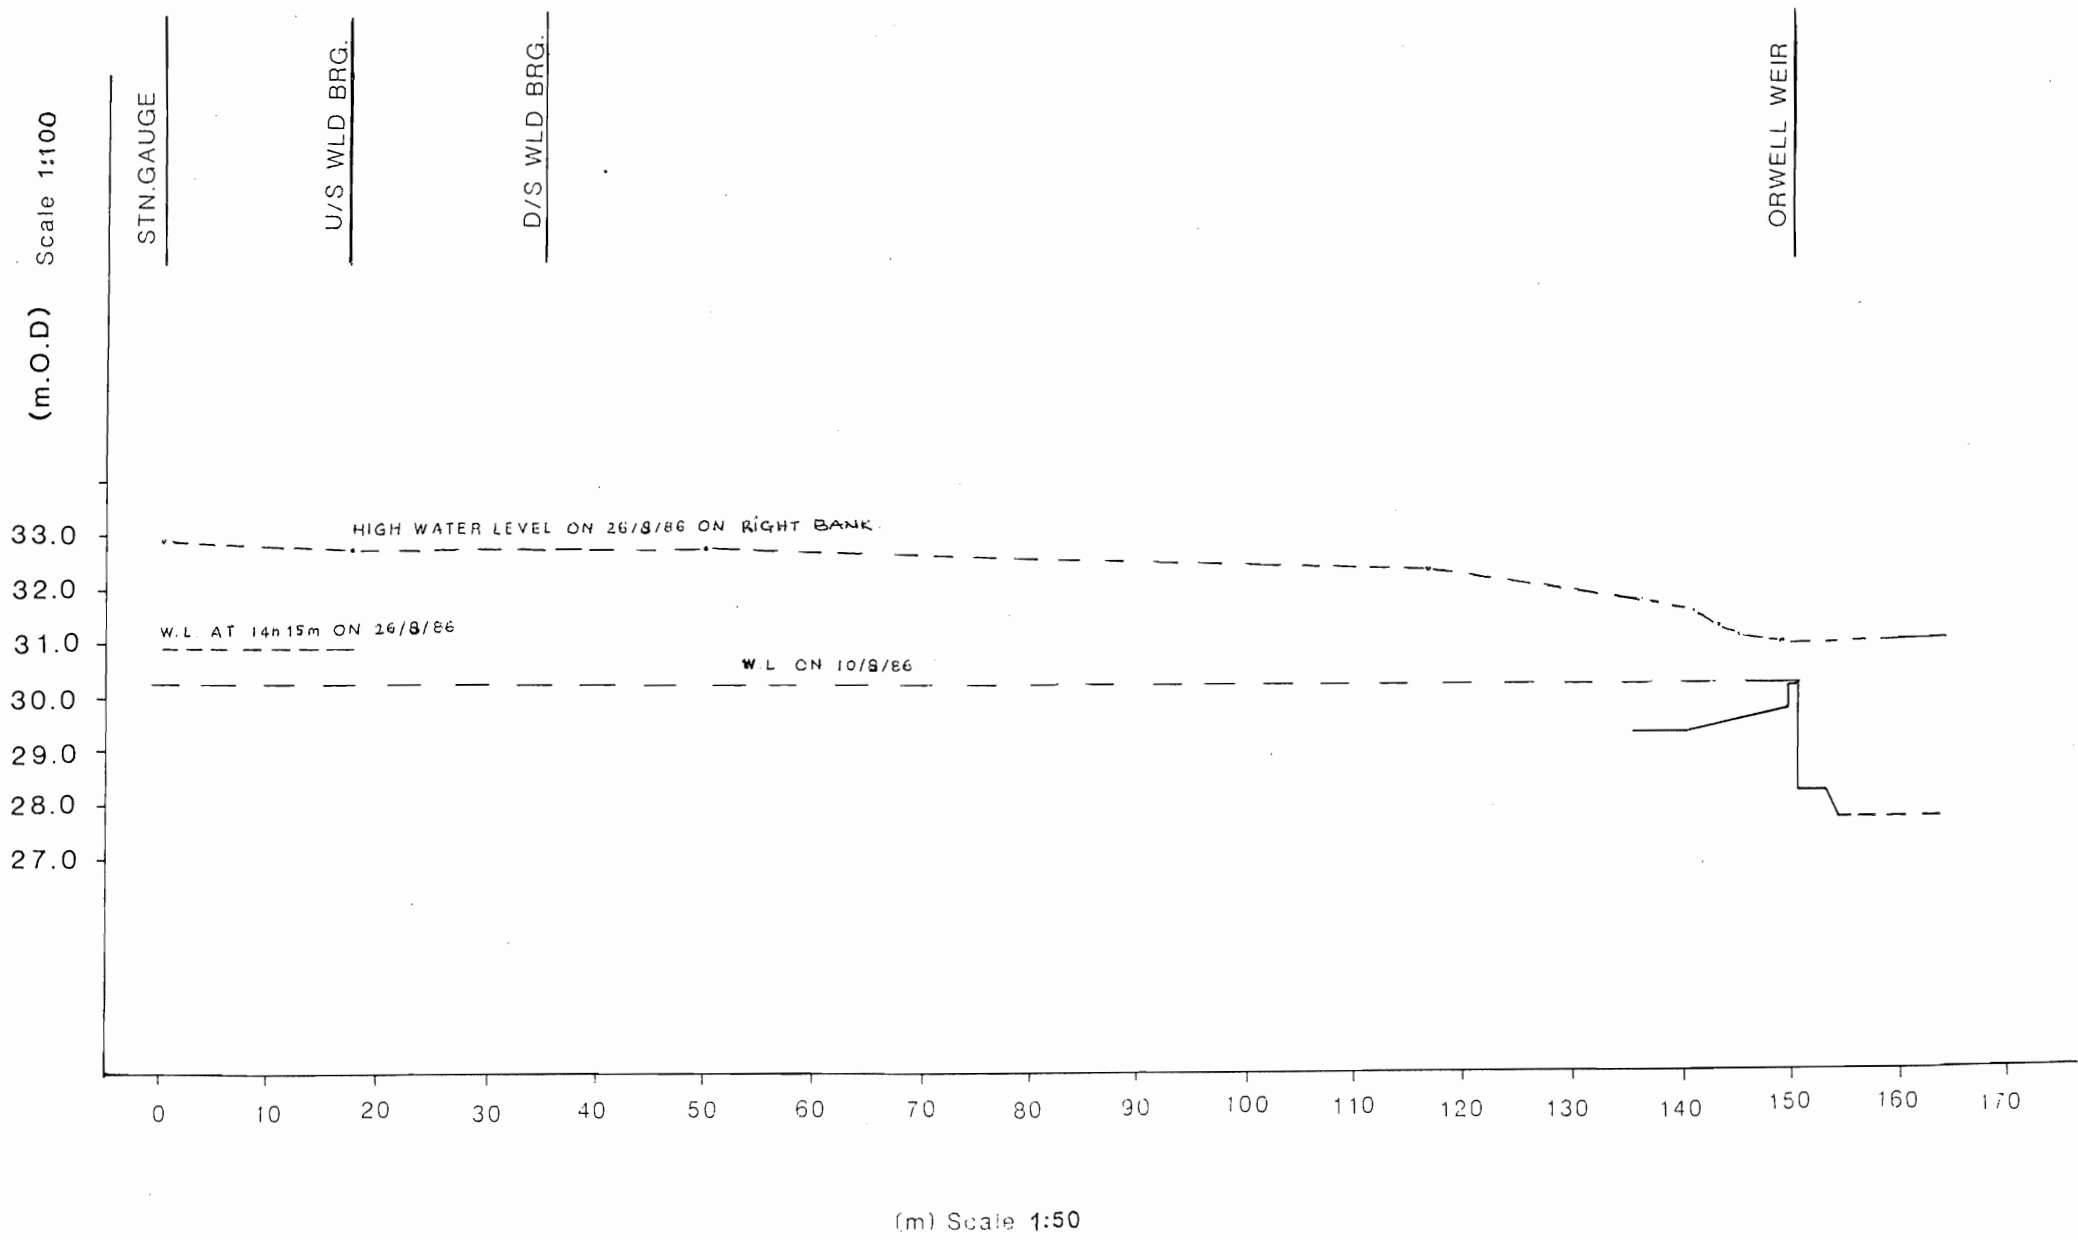
Flows in the River Dodder are measured at Bohernabreena and at Orwell while new flow measurement stations have been operating on the Rivers Owendoher and Slang for the last few years. On the day of the storm the Orwell Gauge operated successfully only until noon of the 25th. However, the level of water was observed at various times during the evening and it was possible to measure accurately the peak flow from a clear high water mark inside the gauge house (33.03 mod). In addition, water levels were noted on the following day by personnel from An Foras Forbartha who also measured the flow in the river at that time. Accordingly, it has been possible to construct with reasonable accuracy the Orwell hydrograph and this is shown in Fig. 1 overleaf.

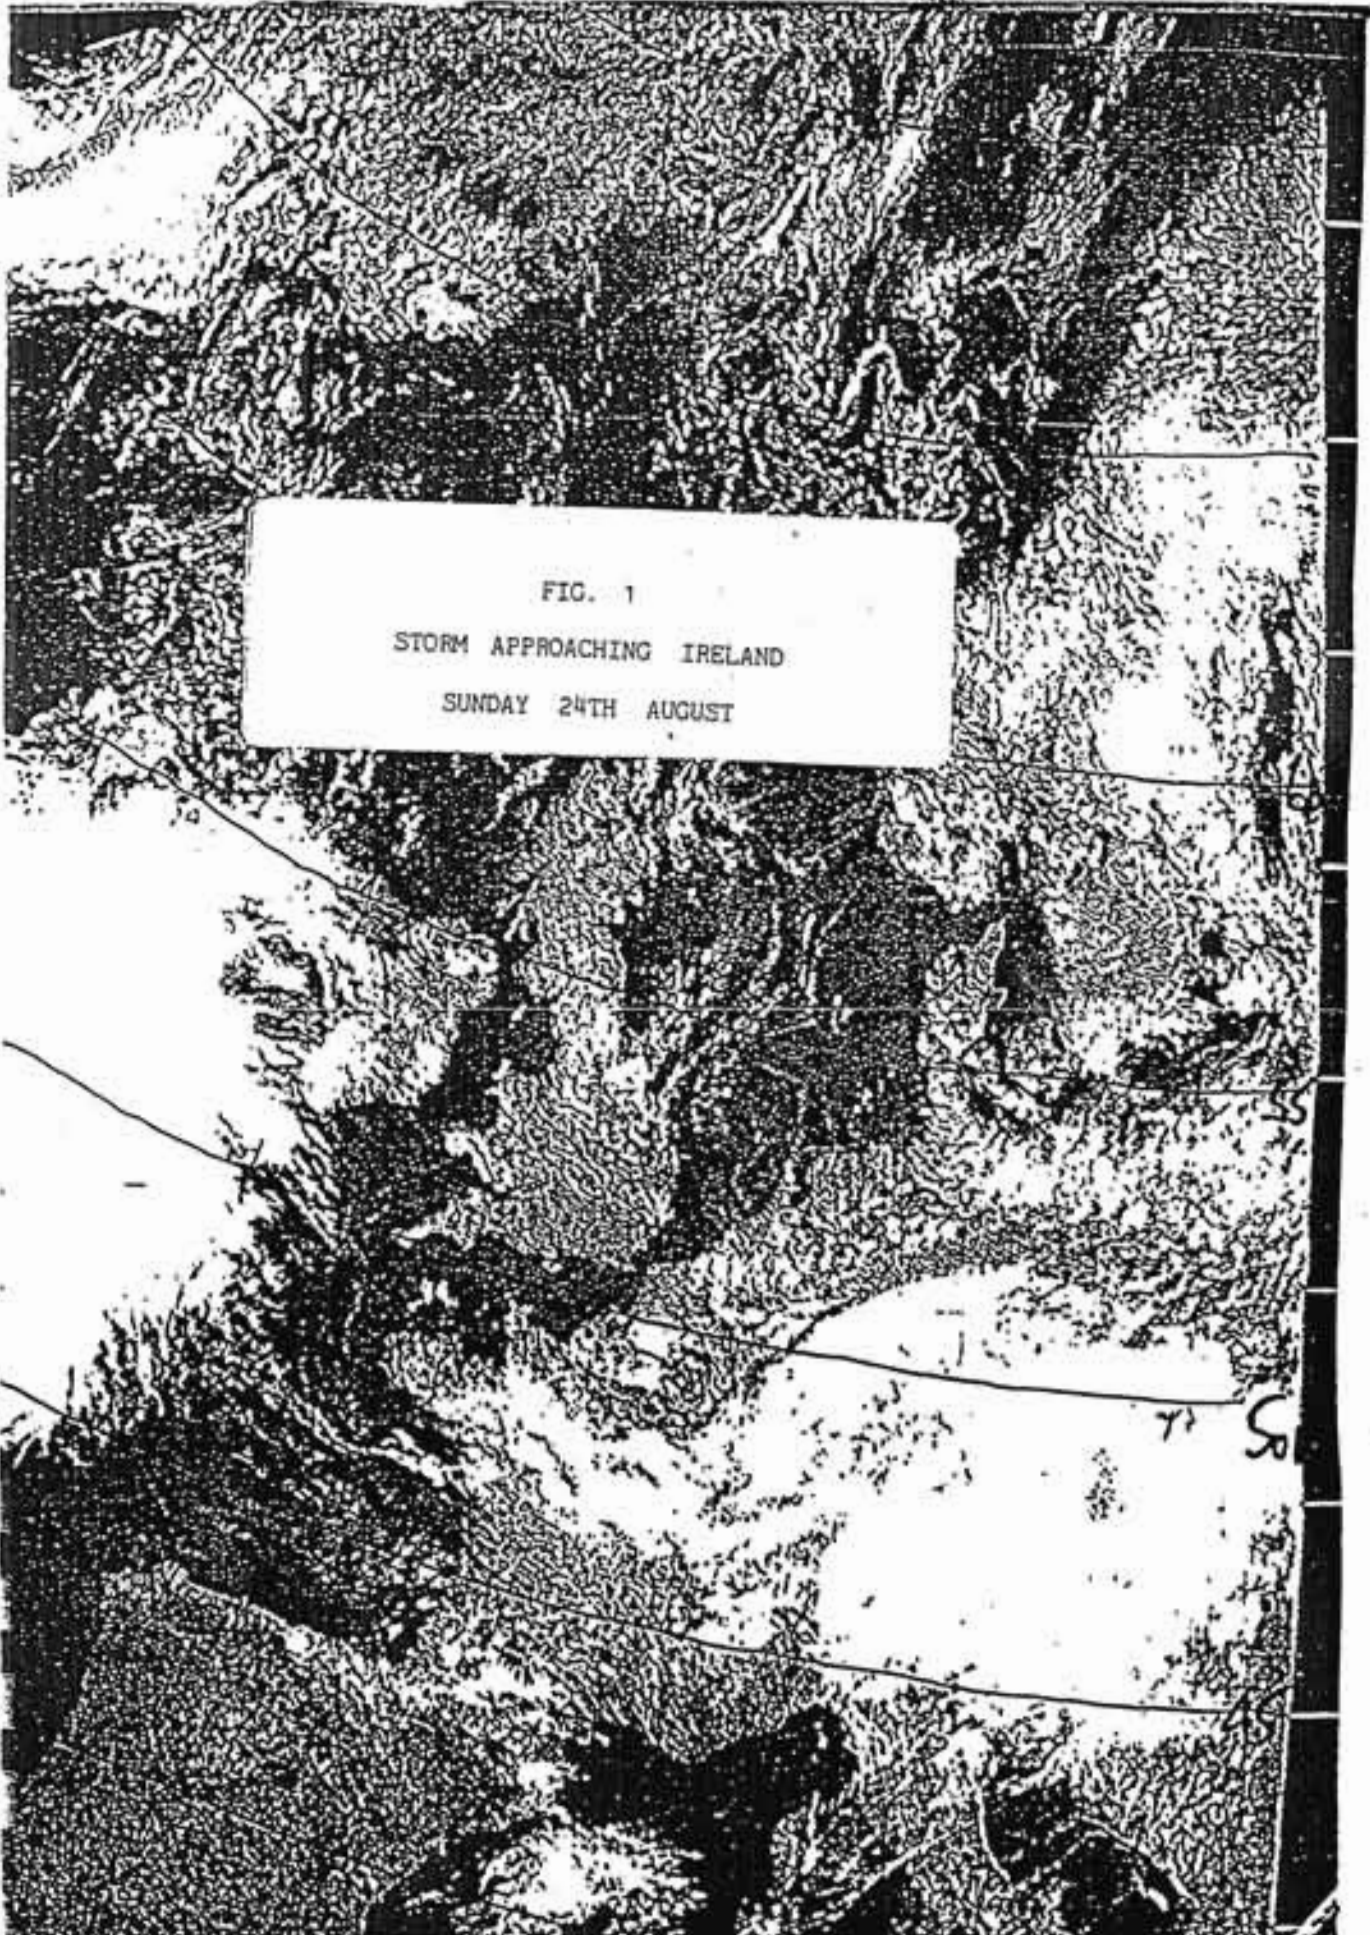
FIG. 1  
STORM APPROACHING IRELAND  
SUNDAY 24TH AUGUST

The satellite photograph (Fig.1) shows the approach of the storm. Fig.2 shows the synoptic weather chart at four by six hour intervals from 12 hours on 25th to 6 hours on 26th.

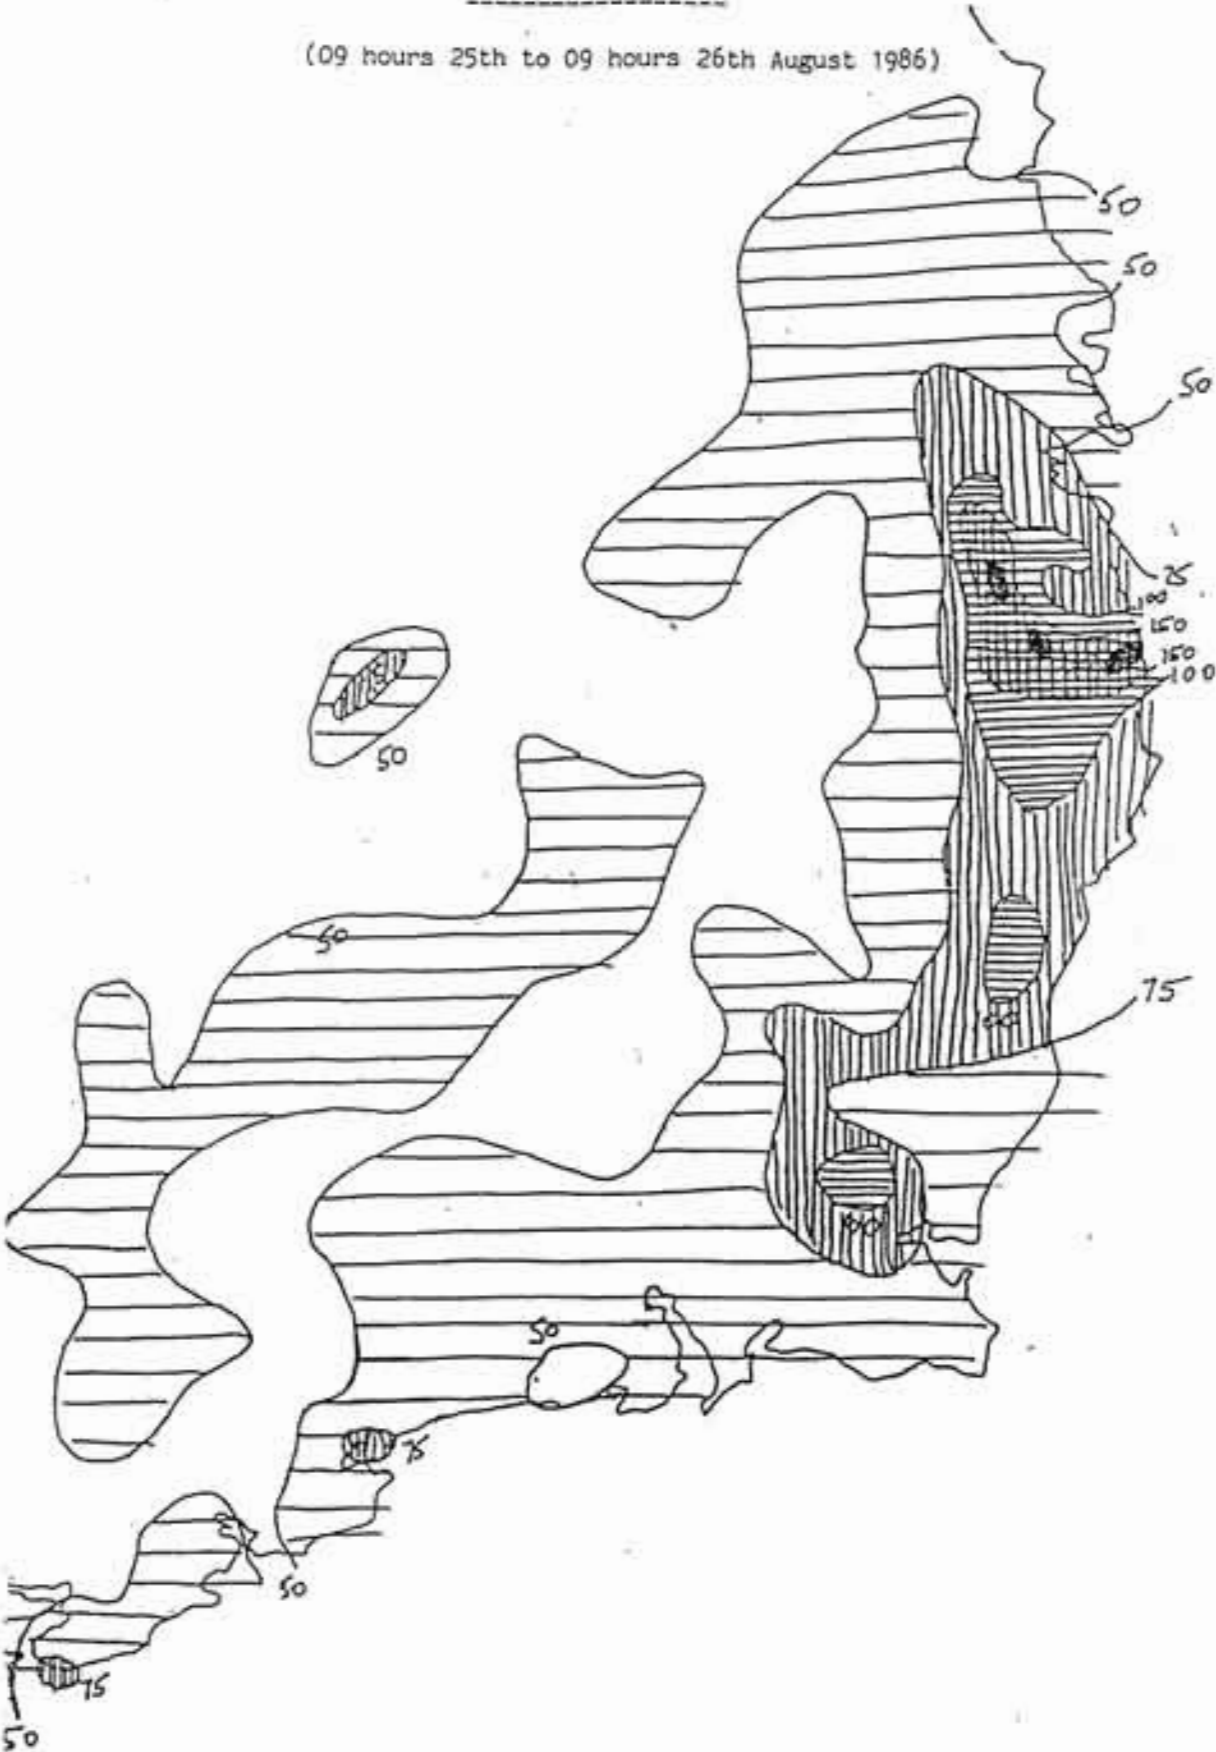
FIG. 3

Fig.3 gives the 24 hour rainfall totals ending 09 hours 26th. 150 mm to 200 mm of rain were recorded in the Dargle and upper Dodder catchments. At the

Phoenix Park, Dublin the 24 hour rainfall total of 85 mm was the highest daily fall since 1905. 75 to 100 mm of rain was recorded over a large part of Dublin/Wicklow in the 24 hour period. Parts of Wexford and the extreme south had similar 24 hour rainfall totals. Roches Point recorded 84.4 mm in a 24 hour period which is comparable to the highest 24 hour rainfall amount (85 mm) on record at the station. However as the heavy rain in the south commenced earlier, part of the rainfall total for stations in the south is recorded for the 24 hour period ending 9 hours 25th. To compare rainfall associated with the storm in the east and along the south coast Fig.4 was drawn showing the 48 hour rainfall total ending 09 hours 26th. Kilcoole, Co.Wicklow was remarkable among the lowland stations recording some 200 mm of rain. At Kippure (750 metres) an estimated rainfall total of at least 250 mm and perhaps as high as 285 mm was reported for the duration of the storm.

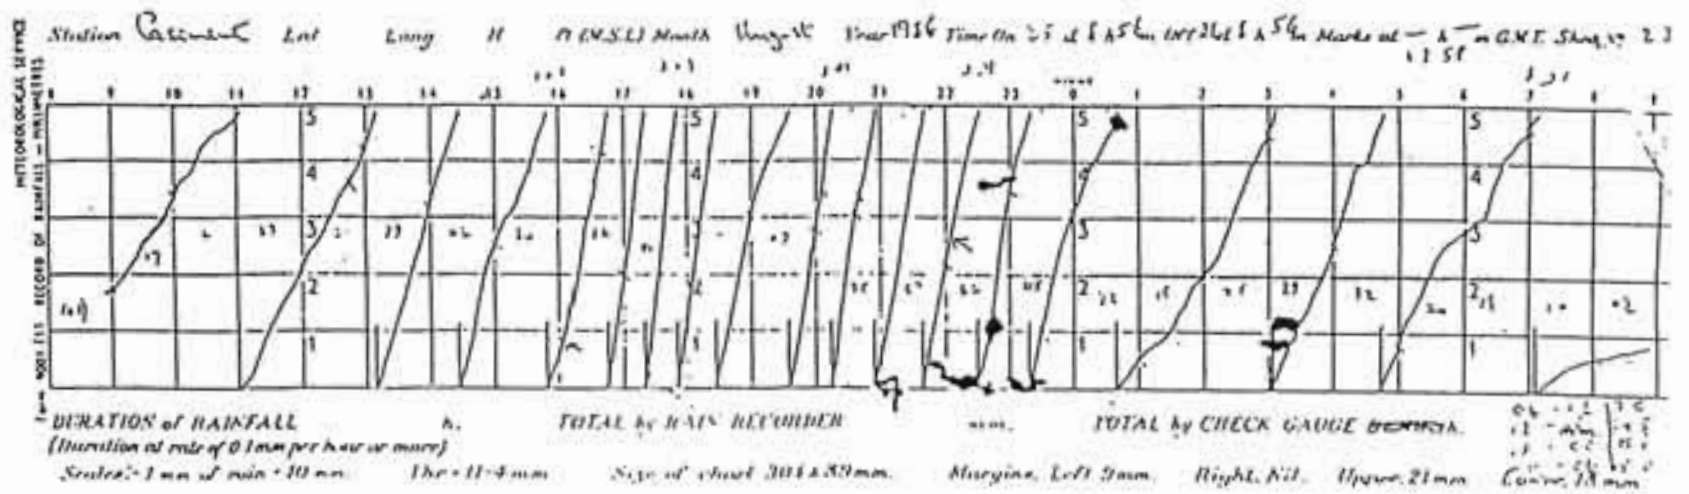
Fig 5

The 24 hour rainfall totals of 89.4 mm at Casement Aerodrome and 65.5 mm at Dublin Airport exceed the previous highest recorded values at these locations. The rainfall total of 41.5 mm in 6 hours and 66.2 mm in 12 hours at Casement Aerodrome also surpass its extreme values for these durations. Fig.5 shows the rainfall chart at Casement Aerodrome which typifies the configuration of the rainfall where flooding occurred. Moderate to heavy rain persisted for most the 24 hour period. The highest 6 hour duration total occurred between 16 hours and 22 hours, and the highest 12 hour duration total commenced at around 13 hours. Each siphon on the chart denotes 5 mm of rain.
